**Annual**

# Environment Report

**2020 - 2021**

**Hobart Airport**  
TASMANIA

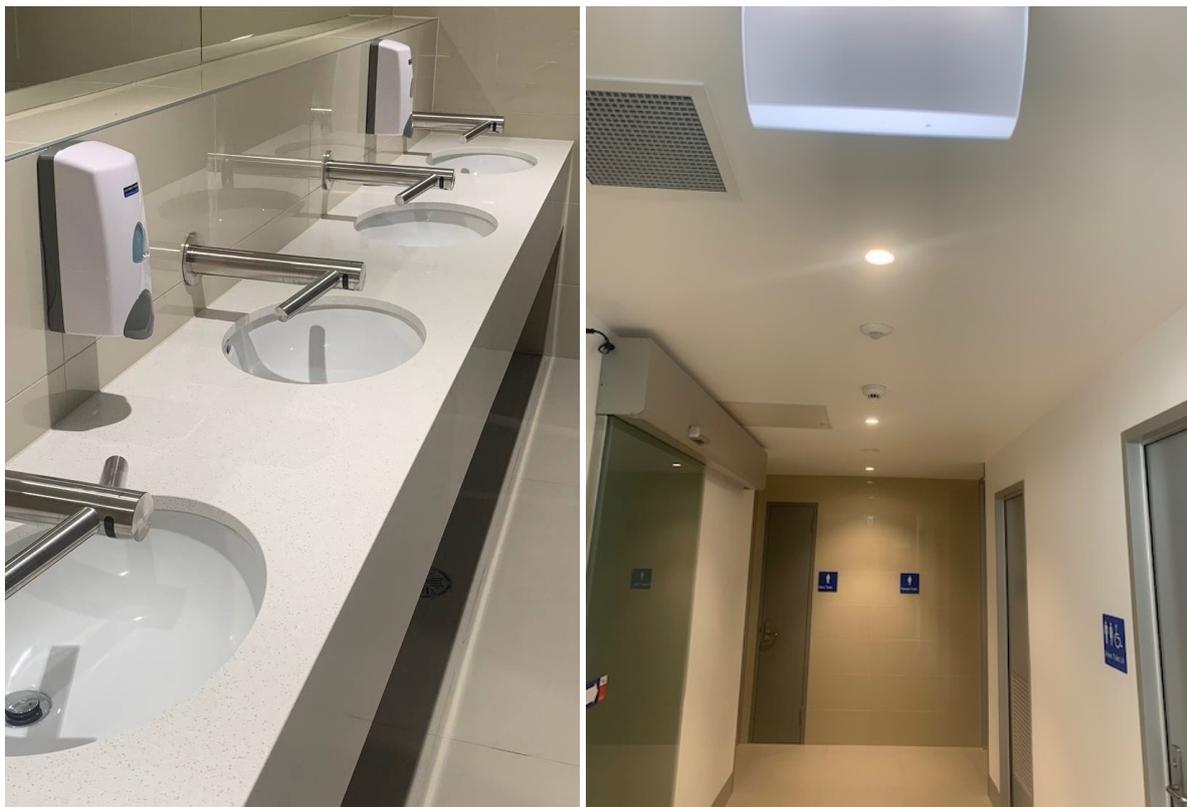
**Figure 3** Water efficient facilities and natural lighting

The re-development of this area includes new amenities that feature both energy and water efficient utilities. LED lighting is used throughout, along with natural lighting and insulation for effective heating and cooling.

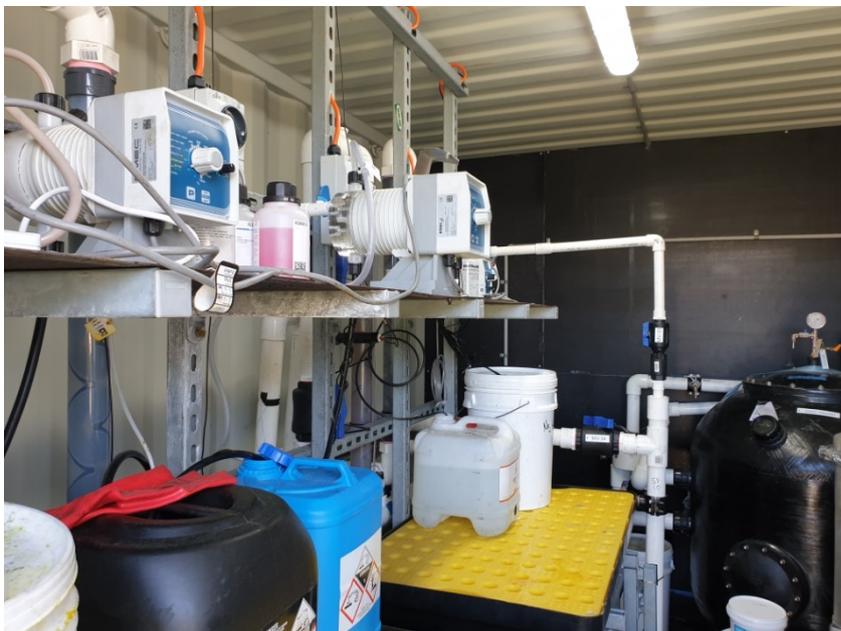
The Airservices Australia (Airservices) fire training ground at Hobart Airport currently produces wastewater from training exercises and rainfall. A research and development trial into the treatment

of PFAS impacted water was initiated by Airservices in 2017, with the first of two treatment trial processes commissioned in September 2018 on site at the Hobart Airport Fire Training Ground. The second trial commenced in January 2020 and continued throughout the reporting period. The purpose of the trials is to assess the potential for the effective treatment of PFAS impacted wastewater along with other co-contaminants from the training

ground. The first pilot trial plant has demonstrated its technical ability to reduce PFAS concentration in wastewater to below Limit of laboratory reporting (LOR). The first trial pilot plant was decommissioned at the end of 2019. The second trial plant is currently in the operational phase. The plant has demonstrated success in removing PFAS from the training wastewater last year however facing some challenges to remove co-contaminants like heavy metals. The second trial has been extended until the end of 2021.

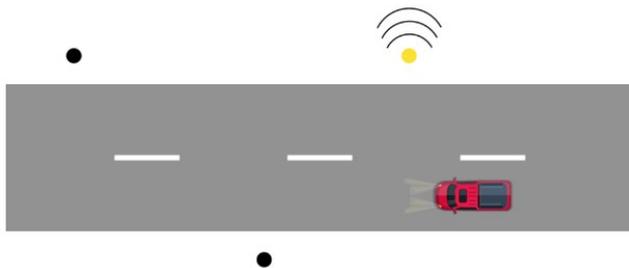
**Figure 6 Virtual Fence Operation**

Virtual Fencing is an active electronic protection system that prevents animals from crossing the road when a vehicle is approaching at night. It has proven to be extremely effective in preventing wildlife-vehicle collisions in Australia and around the world. Latest tests have seen a 60-70% reduction in wildlife vehicle collisions. The virtual fence uses the latest non-invasive audio and visual systems to

alert animals and prevent vehicle contact, all of which are solar powered. This project was undertaken as part of Hobart Airport’s Corporate Social Responsibility platform.

The fence was installed in early May 2019, and in the first 12 months of its installation resulted in a 63% reduction in animal fatalities compared to the previous year. The initiative has been welcomed by the local community, with feedback on a notable reduction in animals being impacted on the road. We know that a number of threatened species utilise the surrounds of the airport, including the critically endangered Tasmanian Devil and the Spotted-tailed Quoll. On this basis, the virtual fence initiative was proposed to ensure potential impacts to all species were minimised.

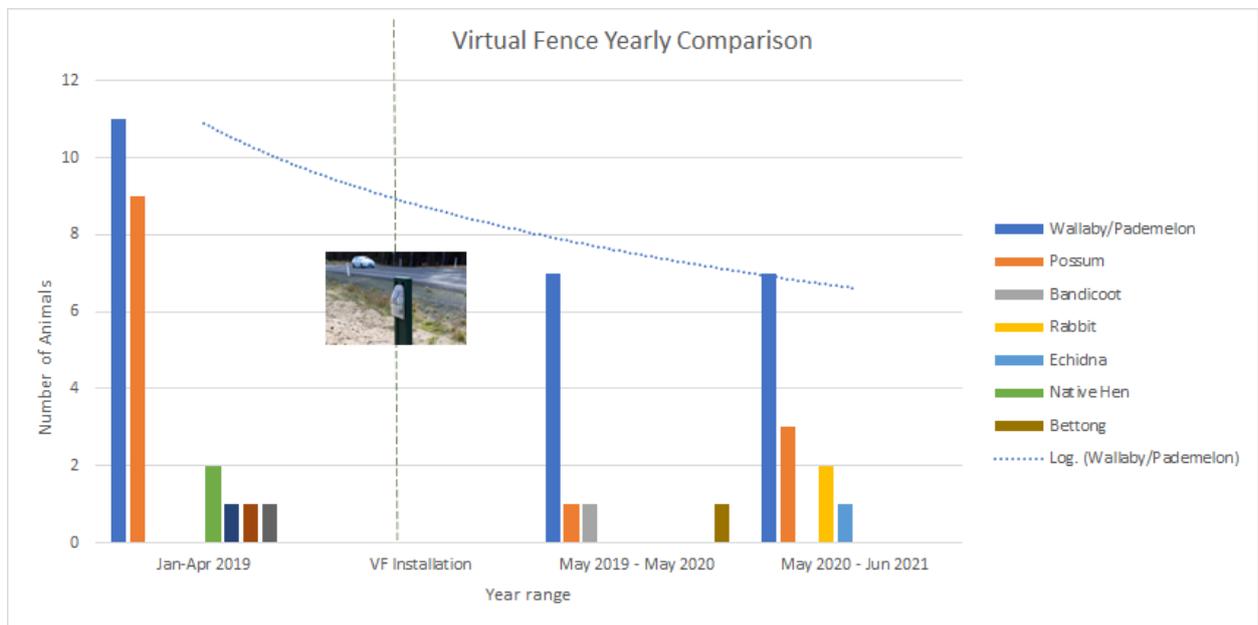
**Figure 7 Virtual Fence statistics since installation**

It is anticipated that reduced vehicle traffic in 2020 will result in skewed data for the current reporting period. Another observation has been notable fauna impacts at the northern end of the virtual fence end. Studies have identified that fence “end-effects” and behaviour habituation have not been fully realised. It is not certain whether the presence of the virtual fence is causing an increase in fauna mortality at the northern end, as this environment also provides increased diversity in habitat and contains a permanent water source which animals would gravitate to. No fence “end-effects” are noted in the southern end; therefore, it is more than likely the animal fatalities in this area are a direct result of habitat and resource availability.

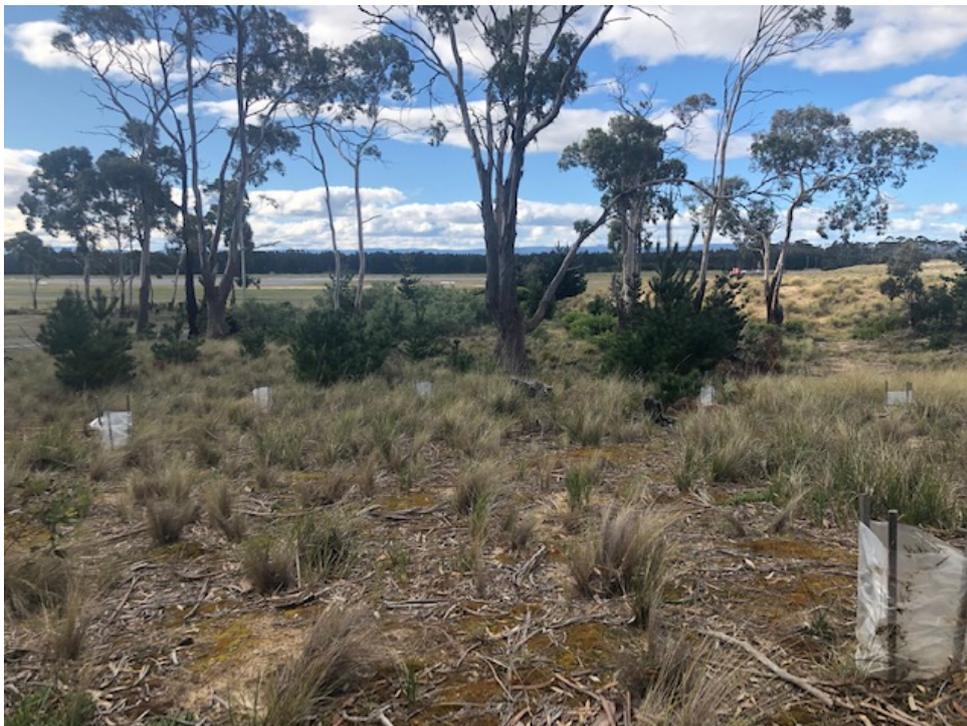
**Figure 9 Juvenile White gum plantings – August 2020 and healthy sapling (right)**

Beach Community in the regeneration of the White gum community, the Airport planted 63 juvenile trees in 2016 and contributes to weed removal in the area to facilitate natural recruitment. The success of the planting is monitored annually and continues four years post planting. This will be the last year in which monitoring will be reported. At the time of reporting, the number of seedlings remaining stand at 25. Ongoing monitoring of the White Gum seedlings will continue, alongside on ground practical efforts to encourage natural recruitment. Measures include removal of coastal wattle (which has a shading effect on juveniles) and pine trees, and the continuation of working with the local Seven Mile Beach Coast Care Group.

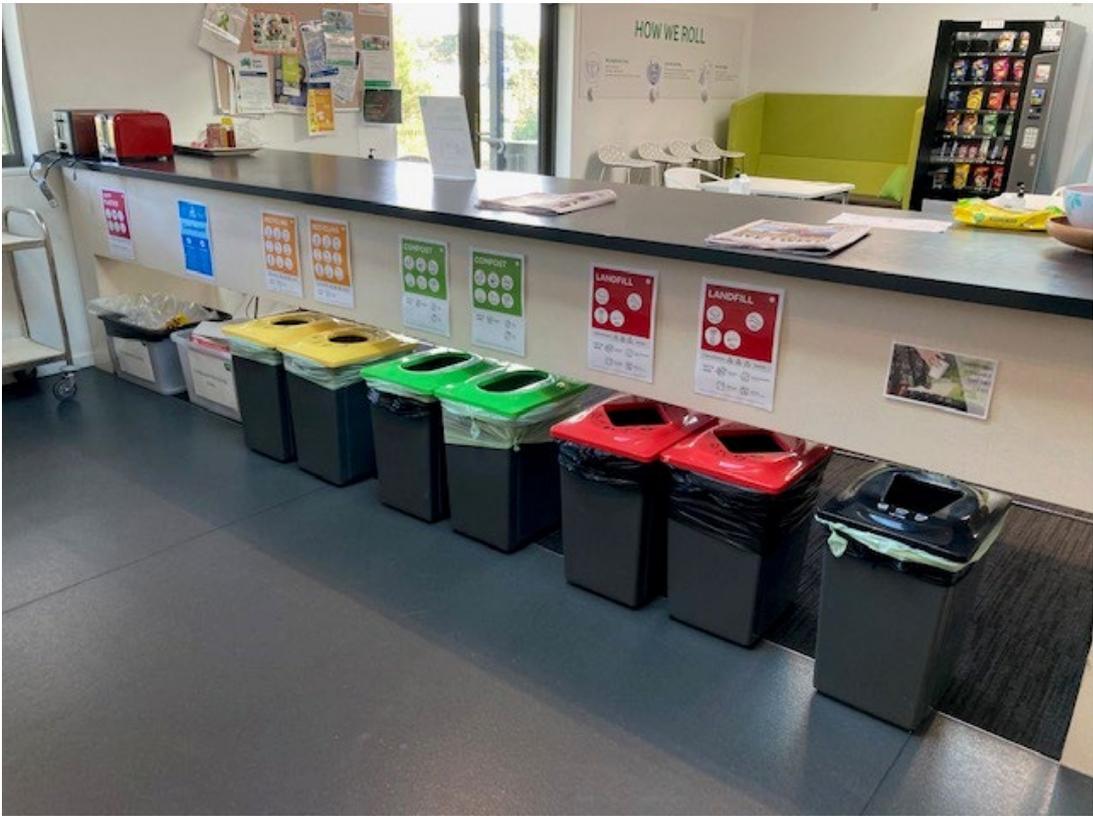
Figure 11 Six-stream waste segregation in the Administration Building

Waste auditing commenced in the Administration building in January 2021. Results indicated opportunities for further segregation as pod bins (landfill and recycling) were indicating cross-contamination regularly. An initiative from the Executive Leadership Team led to the removal of all pod bins and an enhancement of our six-stream segregation system in the kitchen area. This change was initiated to take some of the confusion out of waste segregation in the desk areas and to encourage more efficient segregation using colour coding and educational information. This change was initiated as a trial with the intent to transition towards a permanent arrangement.

To embed improved waste segregation in the Administration Building, a training module was developed for all staff to complete. The module provides waste information relating to the Airport's overarching Waste Management Strategy and sustainability targets, as well as embedding this knowledge through a series of multiple choice questions to test staff knowledge on waste management practices and expectations within the organisation. Waste audits on the Administration bins will commence in July 2021 to gauge efficacy.

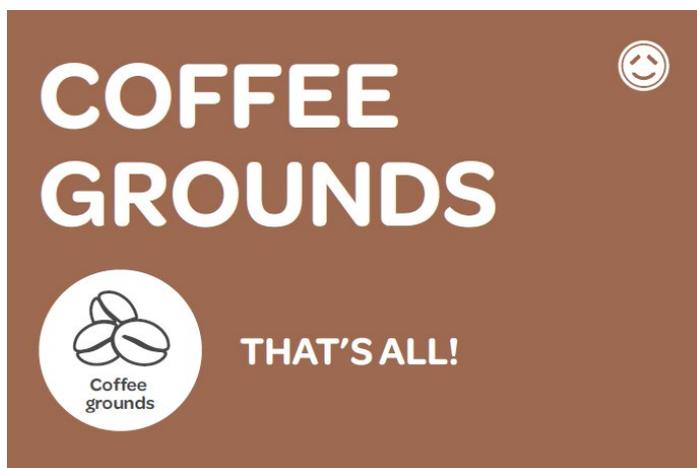
**Figure 12 Coffee ground segregation**

All compostable coffee cups can be diverted to the organics waste stream. Coffee grounds generated within the office building have been segregated for two years. This location is now clearly designated and is in a former bin area. Staff take coffee grounds home for gardening or compost.

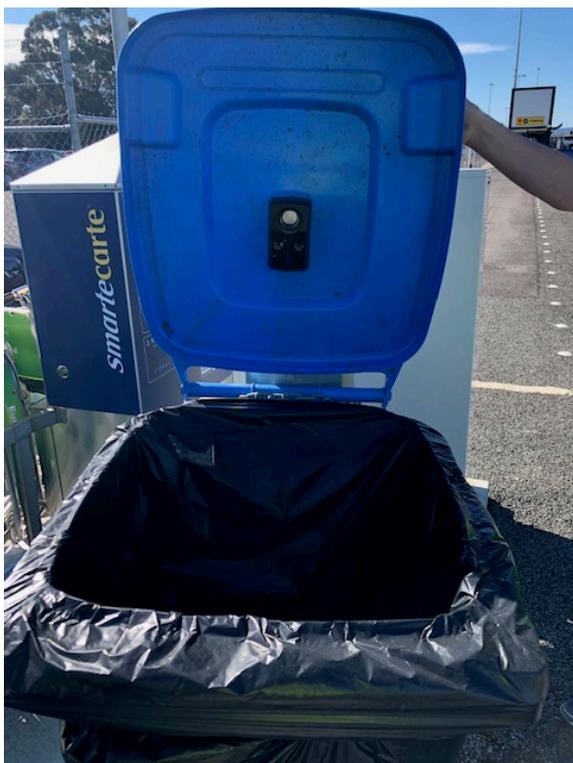
areas and connecting locations. Under normal circumstances, the bins are emptied daily, as per routine maintenance requirements, however not all bins are at capacity when emptied, resulting in smaller collections in some locations and unnecessary use of plastic bin liners which end up in landfill.

To better understand the filling rates of bins, sensors have been placed on 20 bins in car parking areas. The sensors identify when the bin is ¾ full, sending a message via SMS to contractors and therefore improving the efficiency of waste management in car parking areas. The sensor trial was near completion when disruption occurred from the Covid-19 pandemic.

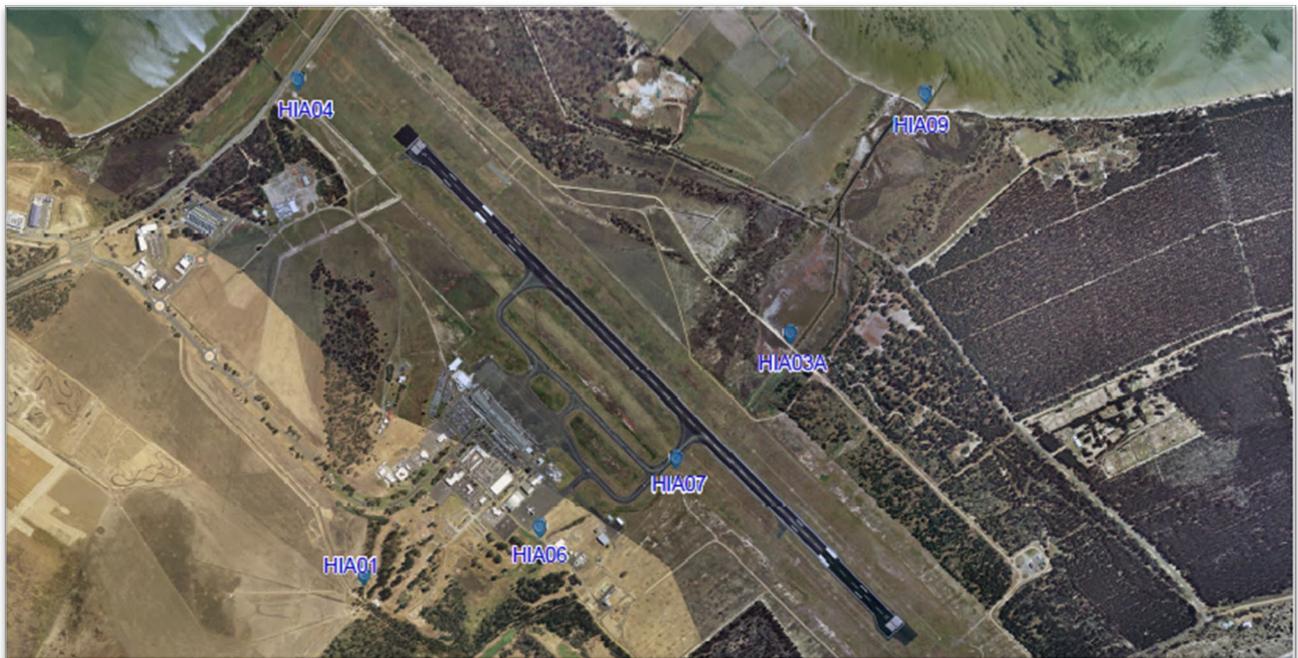
**Figure 14 Surface water monitoring locations**

Sampling Site	Physical location
HIA01A	Upstream at the airport property boundary in open drains (Sinclair Creek catchment)
HIA03A	Downstream drainage channel on estuary of Sinclair Creek catchment at security fence
HIA04	Stormwater swale draining to Barilla Bay, northern boundary
HIA04A	Stormwater drainage line extending from the northern runway extension area
HIA06	Stormwater drain off Gatty Street and buildings complex
HIA07	Stormwater drain from passenger terminal, central area and WWTP discharge point
HIA09	Sinclair Creek confluence with Pittwater at Five Mile Beach

- The conductivity at all sampling locations outside the tidal zone generally characterizes freshwater environments from lowland rivers. Sites within the tidal zone (HIA03A and HIA09) record higher salinity levels, influenced by tidal movement of estuarine waters, with higher levels noted on incoming tides.

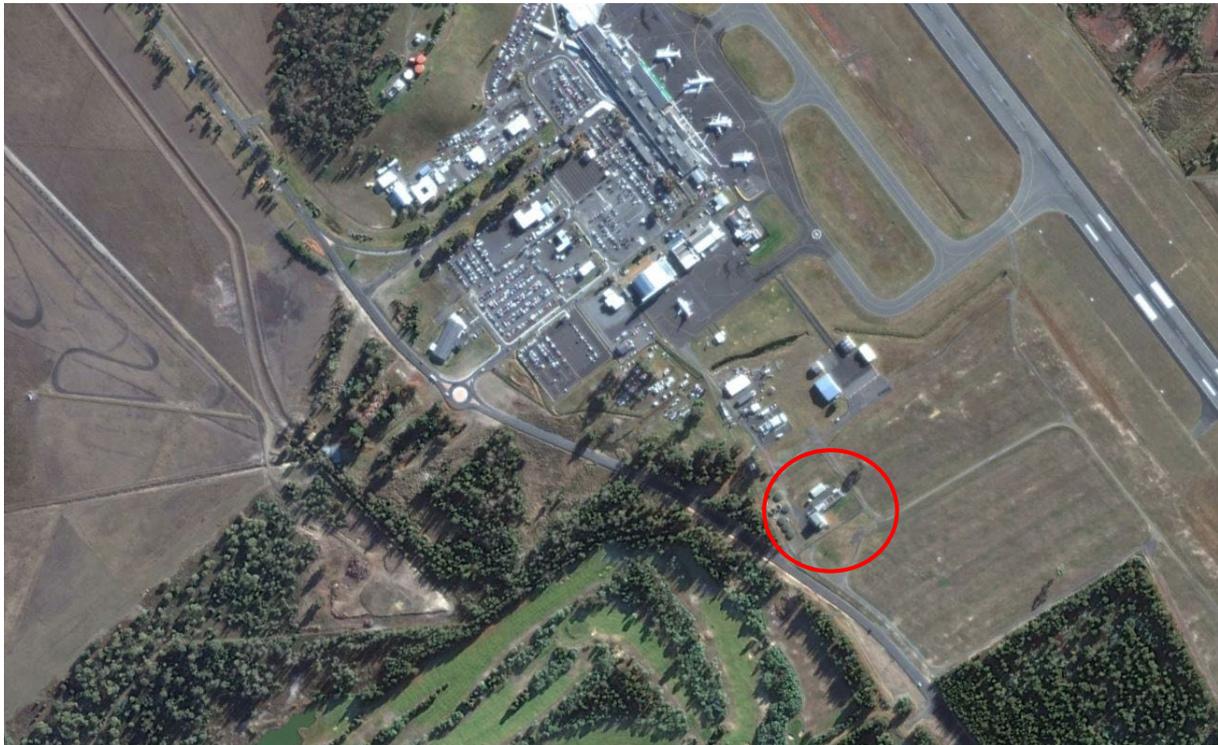
**Figure 15 Cambridge Wastewater Treatment Plant location**

The Cambridge Wastewater Treatment Plant is operated by TasWater and is located on the south eastern side of the airport (Figure 16). The WWTP is regulated by an Environment Protection Notice (EPN) No. 7447/2 which outlines the environmental conditions and limits in which the plant must operate. The conditions are set by the Tasmanian Environment Protection Authority (EPA).
